Visual Inspection Work Instruction

Enhanced Safety Notes — HV Battery Underside Inspection (Model 3 / Model Y)

Battery SN: TG323092000XJK - 'Bessie'

Part Number: 1666969-00-D

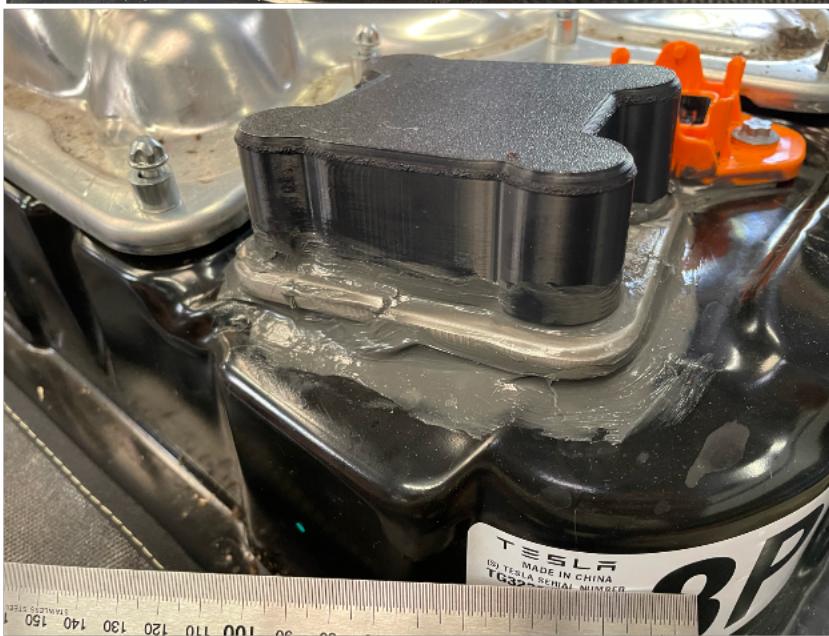
damage of 11
after silica flex repairs.
Considered cosmetic
warranty retained.

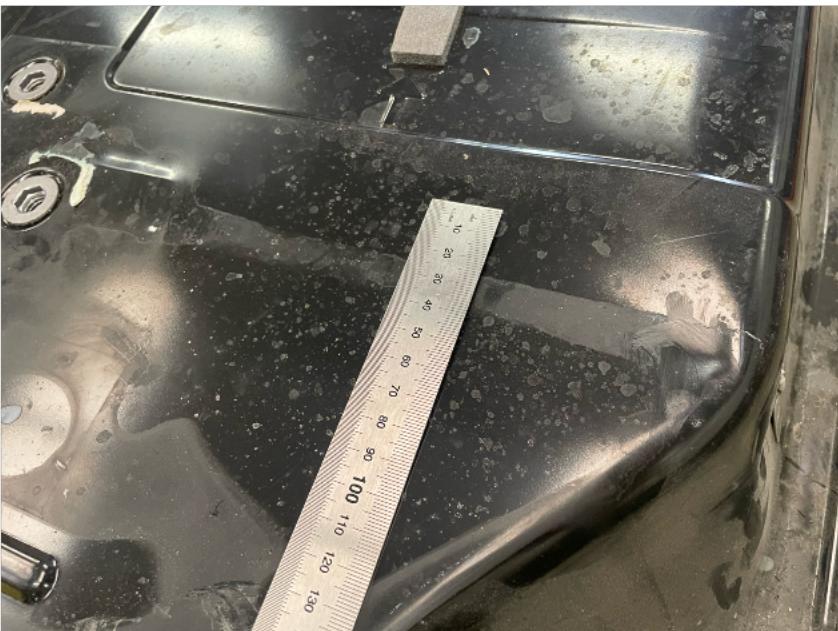
damage of 16
after silica flex repairs
considered cosmetic
warranty retained.

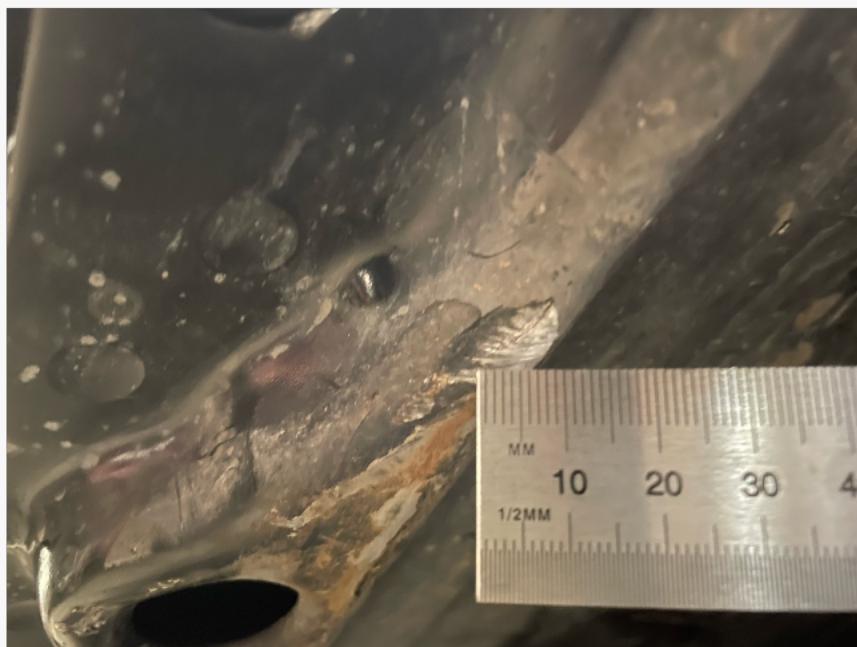
B7 cosmetic damage

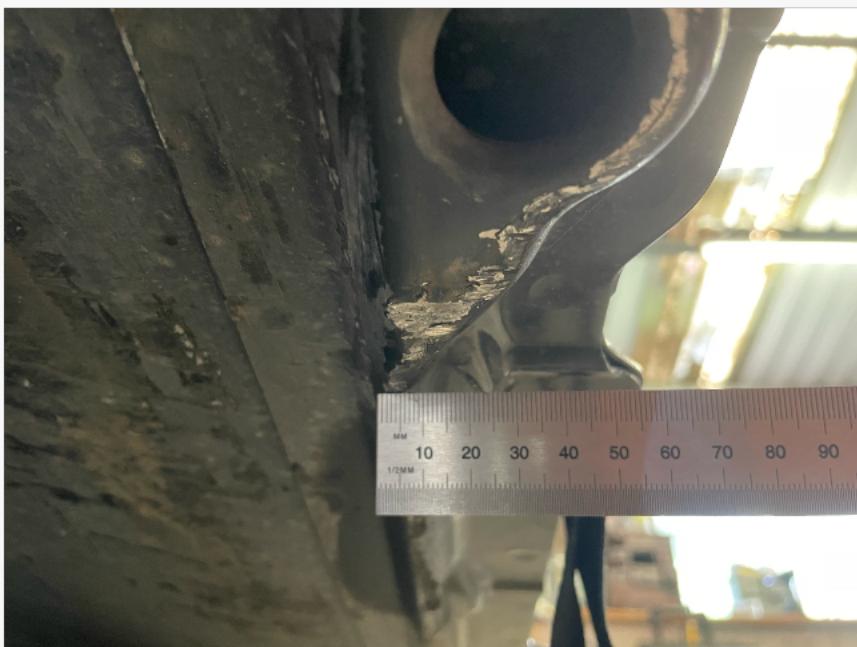
J23 & J31 at
lifting points
cosmeti.

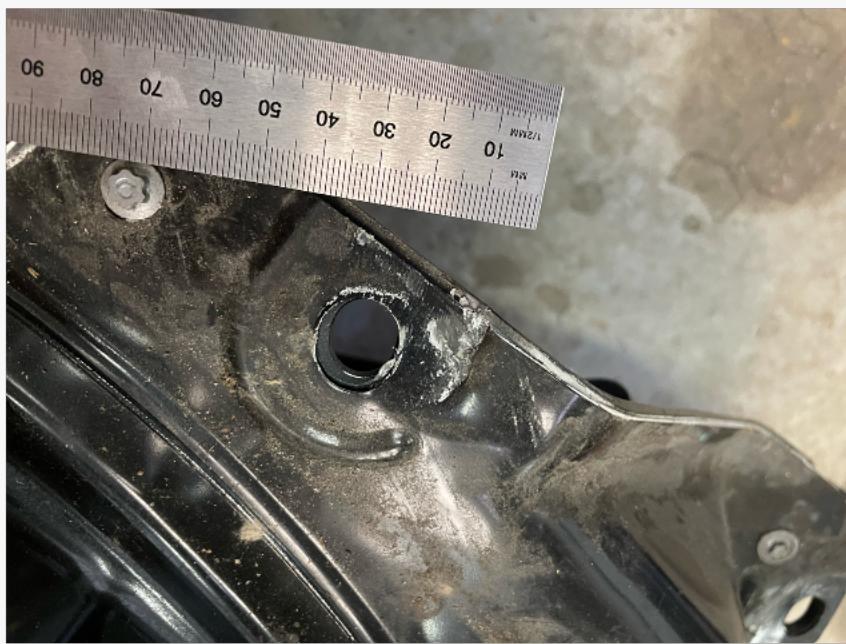
G7 abrasion
