Visual Inspection Work Instruction

Enhanced Safety Notes — HV Battery Underside Inspection (Model 3 / Model Y)

Battery SN: TG323092000XJK - 'Bessie'

Part Number: 1666969-00-D

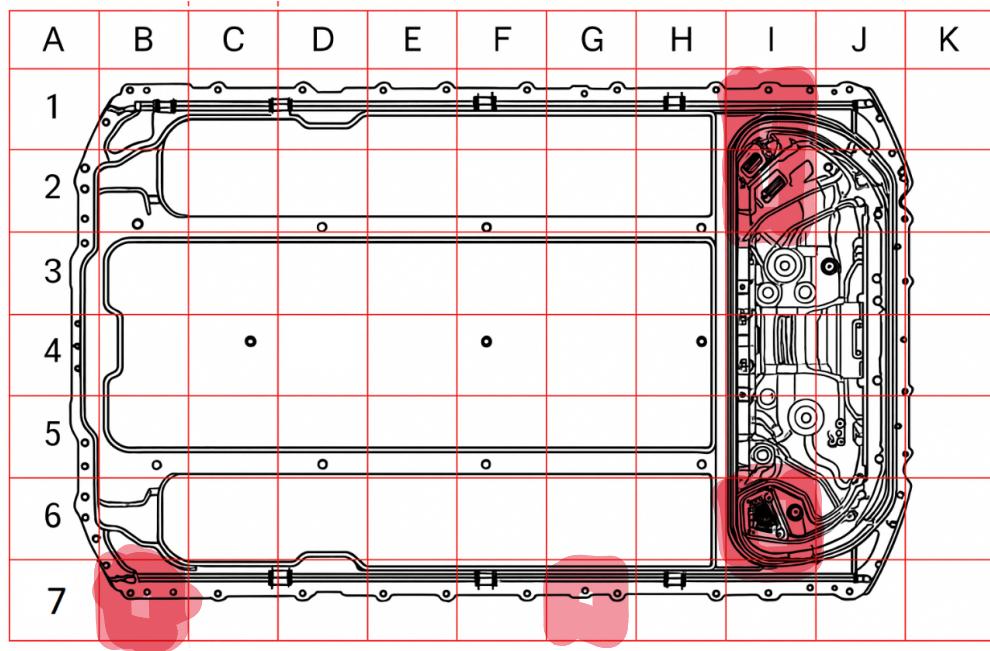
Battery Top

View Type	Grid Location	Damage Type	Risk Level	Notes / Photos
Top	i1	Dent	Moderate	The penthouse enclosure has sustained damage during removal from the vehicle. No damage to internal components.
Top	i2	Dent, Scrach	Moderate	The interface between the sealing surface has been compromised and outdoor sikaflex has been used to maintain IP
Top	i6	Dent	Moderate	As per i1 and i2. Slight change in form of the penthouse enclosure. No damage to internal components, sikaflex used to ensure IP.
Top	i6	Crack	Moderate	DC charging port baseplate is cracked from contact with car chassis during battery removal.
Top	B7	Dent, Abrasion	Low	Cosmetic dent and abrasion.
Bottom	J31	Abrasion	Low	Abrasion at jacking point.
Bottom	J23	Abrasion	Low	Abrasion at jacking point.
Top	G7	Abrasion	Low	Abrasion at outer bolt hole.

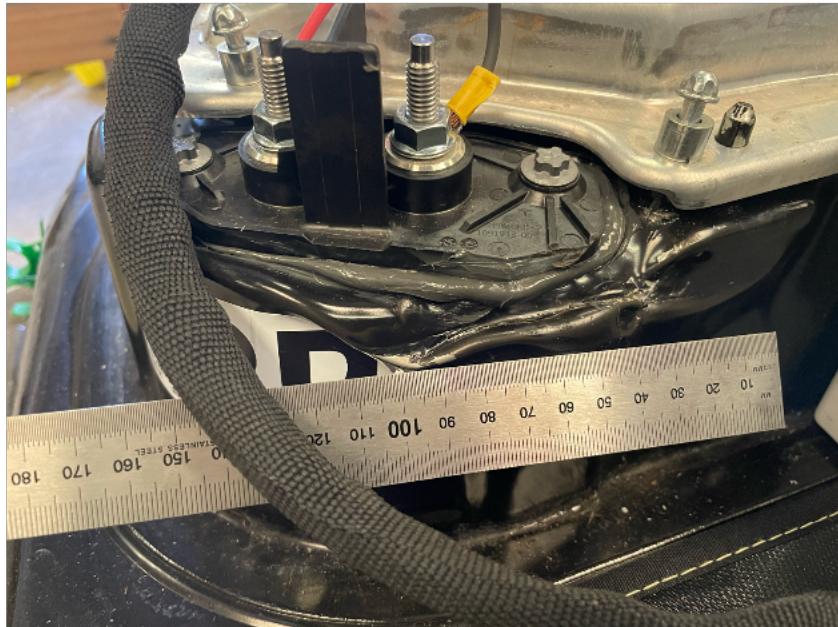
Assessment Summary Findings

damage of 11
after silica flex repairs.
Considered cosmetic
warranty retained.
